Manhole Inspection Summary

Manhole # S23SS1017MH

Insp Date: **6/15/07 11:30 AM**

Location Address: **109 EDGEVALE RD**

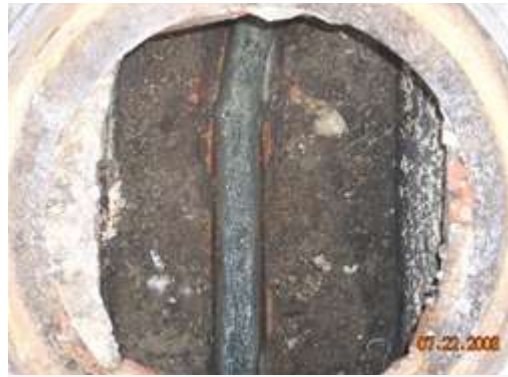
Top View

Evidence of surcharge - Bench debris.

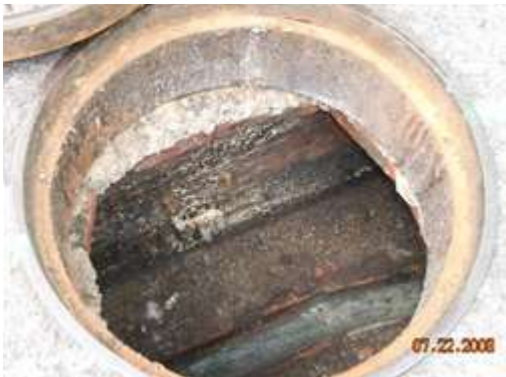
Defect

Condition: ☐ Sound ☐ Cracked ☐ Root Intrusion ☐ Loose Brick ☒ **Deteriorated**

Infiltration: ☐ None ☒ **Joint** ☐ Cracks ☐ Mortar ☐ Roots ☒ **Wall**

Corbel deterioration and infiltration. Barrel infiltration.

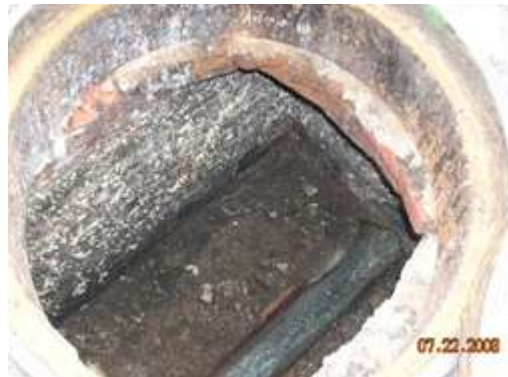
Defect

Corbel deterioration and infiltration. Barrel infiltration - other side.

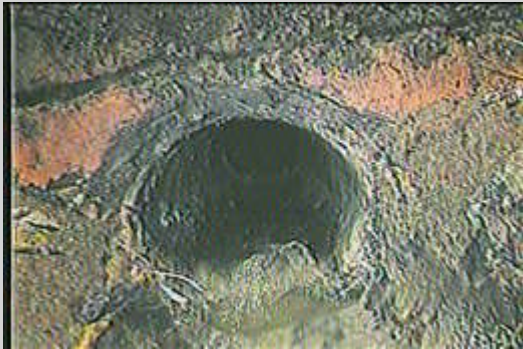
6 in. Circular Gravity Sewer Pipe Out @ 12 O'Clock

Infiltration: **Evidence** Pipe Seal Cond: **Cracked**

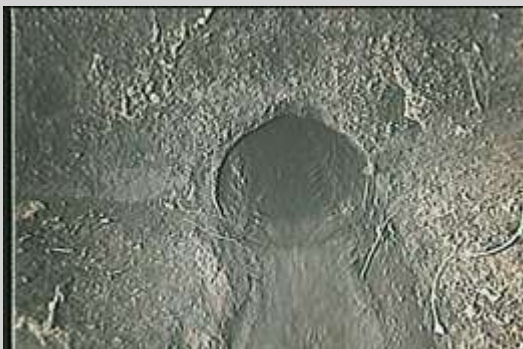
6 in. Circular Gravity Sewer Pipe In @ 6 O'Clock

Infiltration: **None** Pipe Seal Cond: **Broken**
